A Case Study of Site Conditions and Ground Stability of Town Homes

Tomas U. Ganiron Jr

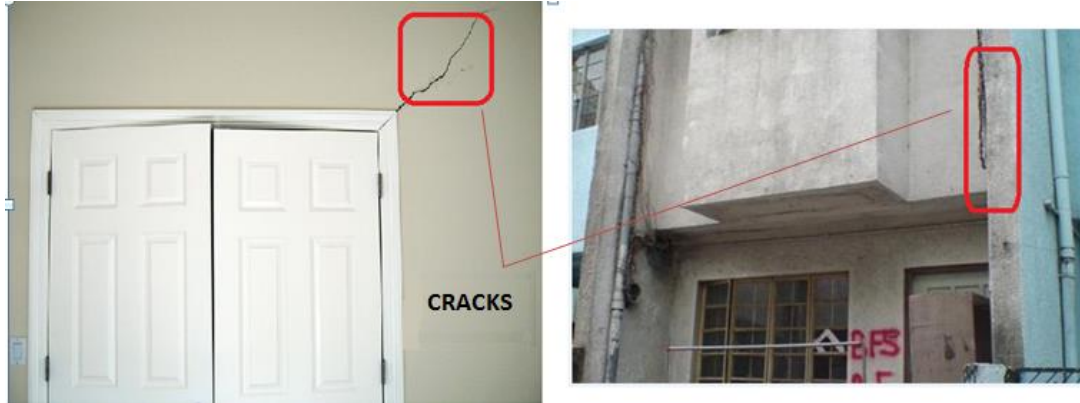
The residents of Villa Milagrosa cited some changes on the structure of their houses. The residents of Block 3 and 9 noticed crack on the walls and slabs brought by the collapse of the riprap that support its foundation shown in figures 1 and 2. The water pump that supplies the residents is also affected due to the effect of soil erosion on the pipes and steel reinforcements.

Figure 1. Cracks in Walls

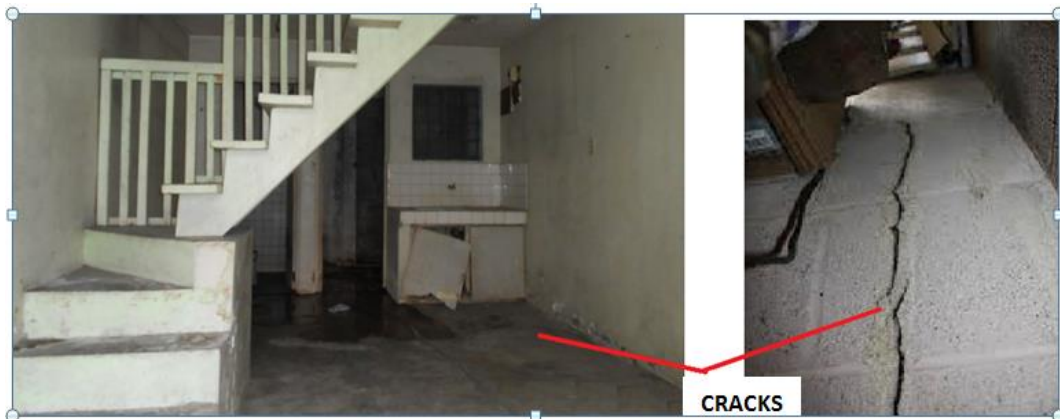
Figure 2. Cracks in Slabs

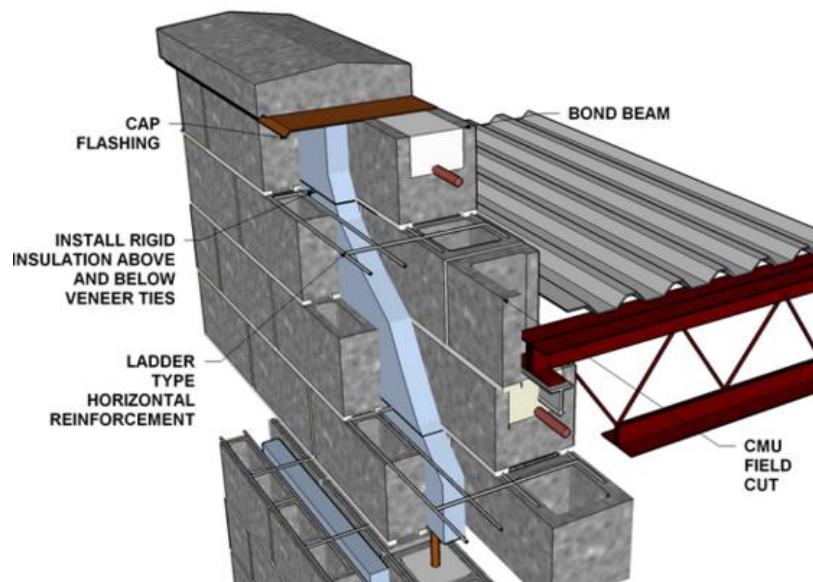
The Villa Milagrosa Townhomes (VMT) used 9-gauge horizontal joint reinforcement every 32 vertical inches throughout the entire house shown in figure 4. This is not a local code requirement, but VMT chose to use the joint reinforcement as good practice.

Figure 3. Horizontal Truss Type Joint Reinforcement and Bond Beam

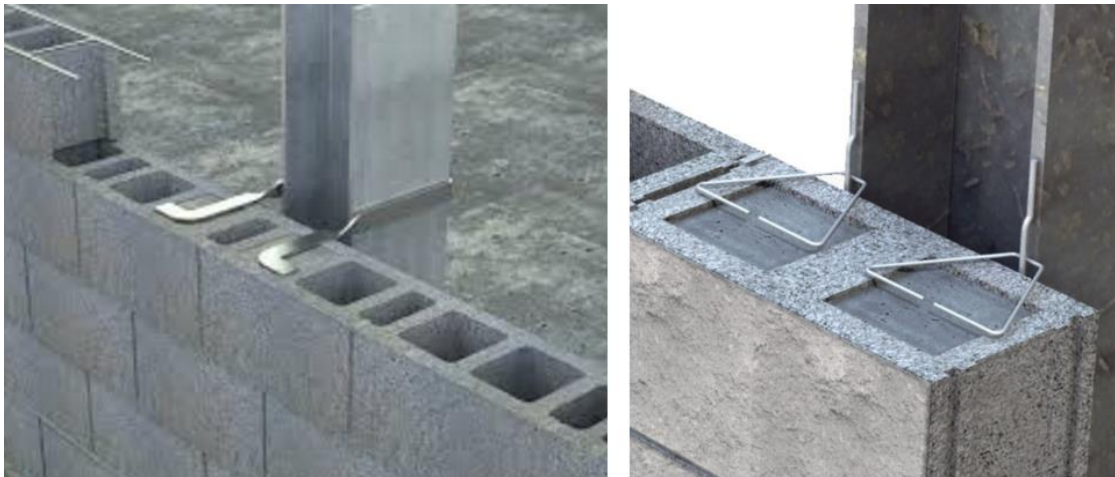
With the 8-inch thick, hollow-core block used at VMT site, table 2 prescribes that the maximum spacing (measured either vertically or horizontally) of lateral support is 12 feet (8 inches x 18 = 144 inches or 12 feet). The floor diaphragm is anchored to the wall with $\frac{1}{2}$ " diameter bolts in the sill plate at 4'-0"o.c. as shown in figure 4 and the roof is anchored to the wall with anchor bolts in the top plate at 32"o.c., and wind tie-down straps).

Figure 4. Tie-Down (Anchor Bolt) at VMT Site

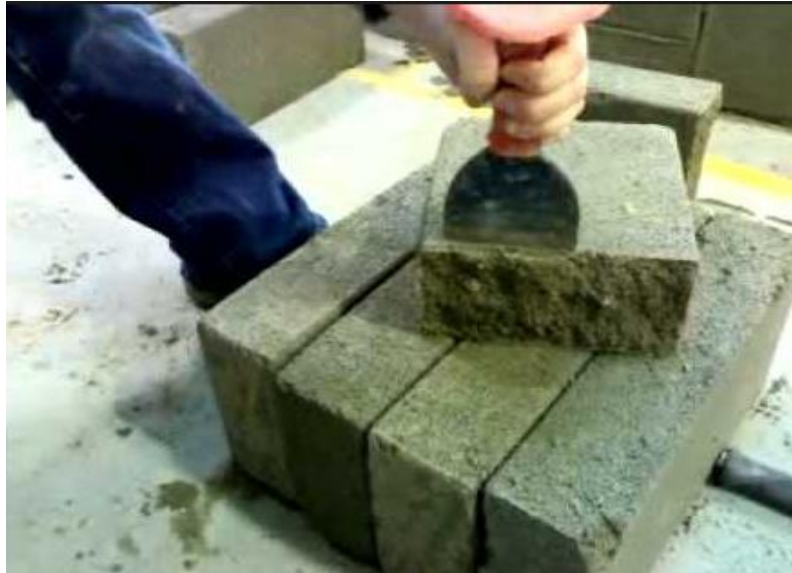
VMT also used a half-high, split-face block on all four sides of the house, chosen primarily for its appearance and durability shown in figure 5. The exterior sides of the masonry walls were sprayed with a siloxane surface treatment to provide a layer of water repellency. An integral water repellent treatment was not used as the builder felt this would compromise the bond between the unit and the mortar. The VMT was insulated on the interior side of the block with $2\frac{1}{2}$ " of polyisocyanurate, which was glued to the face of the block. A narrow cavity ($1\frac{5}{8}$ " deep) was framed with light-gauge metal studs to provide a cavity for running electrical wiring. This thin metal stud wall was fastened to the floor and ceiling assemblies (bottom of floor trusses and roof trusses, slab, etc.). A small bead of adhesive at mid height (glued to the insulation boards) provided additional stiffness to the metal stud assembly. The interior finish was gypsum wallboard which was fastened to the interior side of the metal stud walls with screws.

Figure 5. Half-High Split-Face Block at VMT Site
