## A Method for Data-mining of Defects on Building Façade Elements

### **Abstract**

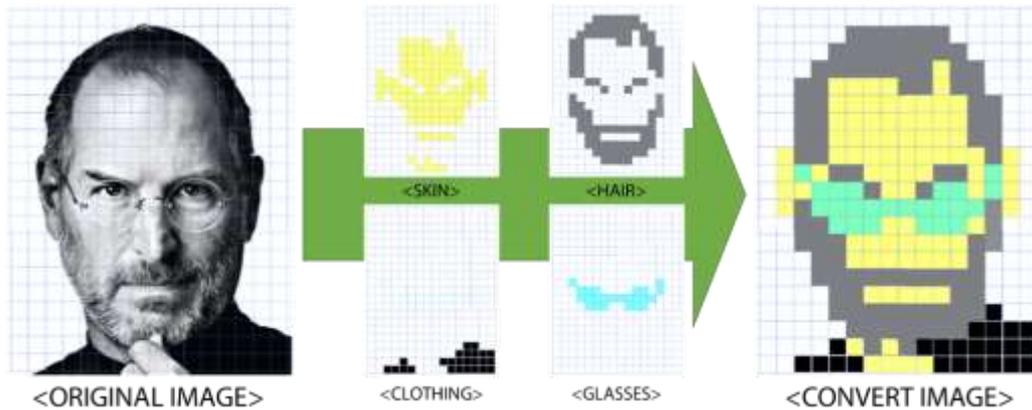
Figure 1. Concept of Pixelization Method

Suppose information about the skin, hair, clothing and glasses are obtained from a human face. First, a grid line is drawn above the image of the human face (<ORIGINAL IMAGE> in Figure 1.) and a compartment unit is created. Then, the data is checked based on the presence or absence of each factor in the compartment unit. Finally, the data is combed to create the final database (<CONVERT IMAGE> in Figure 1.).

Comparing <ORIGINAL IMAGE> and <CONVERT IMAGE>, the overall characteristics can be observed, but some detailed information is missing. This is a weak point of PM, but considering the data mining process and the characteristics of the information, the range is acceptable and can be complemented with additional study.

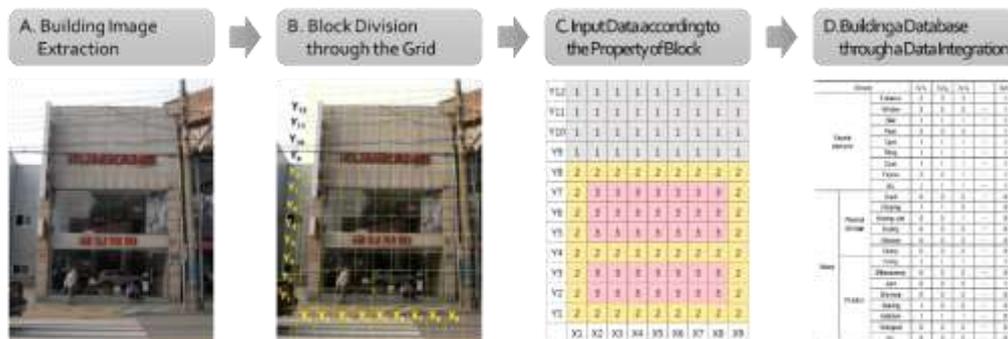
Figure 2. Process of Pixelization Method (J.S. Lee, 2016)

PM consists of a process that separates a building image into compartments, inputs codes for the characteristics in each matrix and converts each matrix to the database matrix. The detailed process is as follows (Figure 2.):

2 is used for an adjacent area (Figure 2. C). Codes for other factors are inputted similarly

The matrix is formed by a number of factors (n), and the data for each matrix is converted into one matrix. In other words, n matrixes (H×W) are converted into one matrix (k×n, k=H×W). The final matrix is used for the database of the building façade elements or defects (Figure 6.). Figure 2. D shows the results of converting 9 façade elements and 14 defects into one matrix. So, a total of 23 matrixes was converted into 1 matrix.

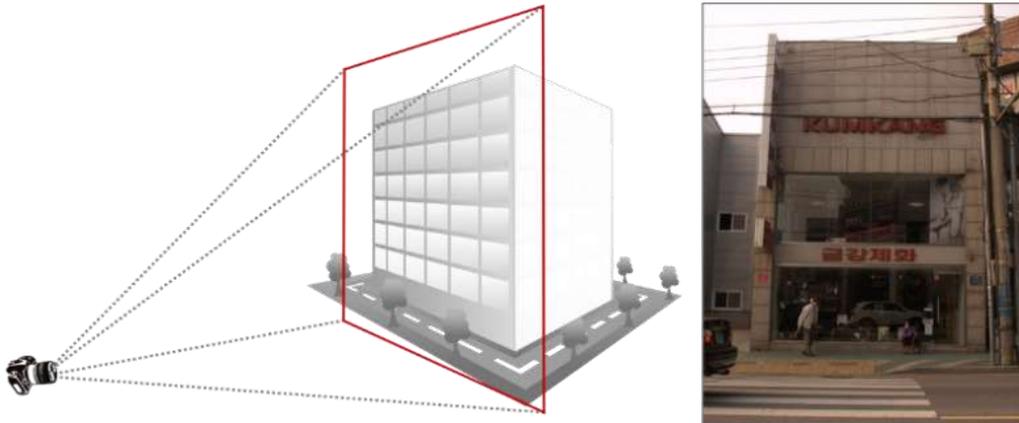
**Figure 3. Building Image Extraction**

To divide a building façade into compartments, the image of the building façade must be collected first. The actual appearance is required, so pictures should be obtained from the front of the building. To minimize the distortion according to the viewpoint, the façade is fit within one frame in the image. Therefore, there is a limit on target building size, but this limit can be complemented through additional study (Figure 3.). Figure 2A. shows an example of image data. The compartments are separated and data collection based on the compartments is performed in the next step.

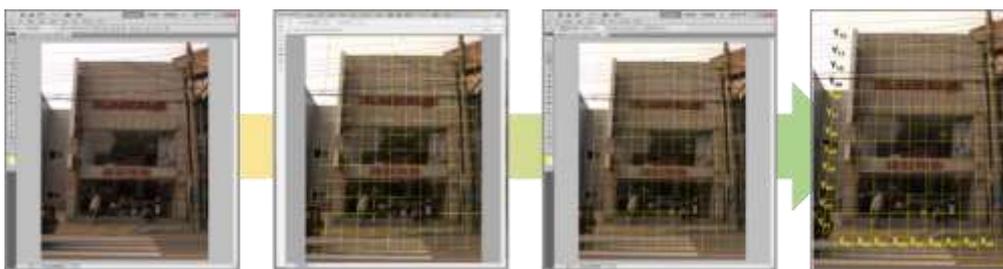
**Figure 4. Block Division of Image through the Block**

The image obtained in the first step is divided into compartments. The compartment size is 1×1(m) and the number of compartments (H×W) varies depending on the height (H) and width (W) of the building. In consideration of possible distortion due to the linear perspective, this study uses the ‘vanishing point’ in Photoshop@ to draw the interval lines. Based on the grid, codes are assigned to each unit (Figure 4.). Figure 2. B shows an example of the grid in the image. In this case, the building was divided into 108 compartments (H: 12, W: 9).

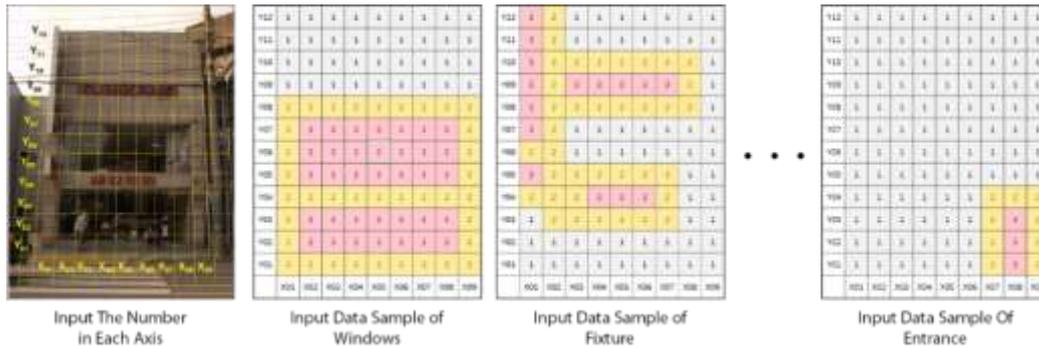
**Figure 5. Input Data According to the Block Property**

Data is inputted based on the characteristics of the compartments in the image. Prior to input, entry factors should be set in advance according to the factors to be analyzed or collected. Each factor should be capable of being visually separated into façade elements or defects (Table 2). Each factor has a H x W matrix, and codes are inputted in the presence or absence of factors (Figure 5.). In Figure 5. B, X2Y2 to X8Y3 and X2Y5 to X8Y7 are windows, so code 3 is inputted for windows and code

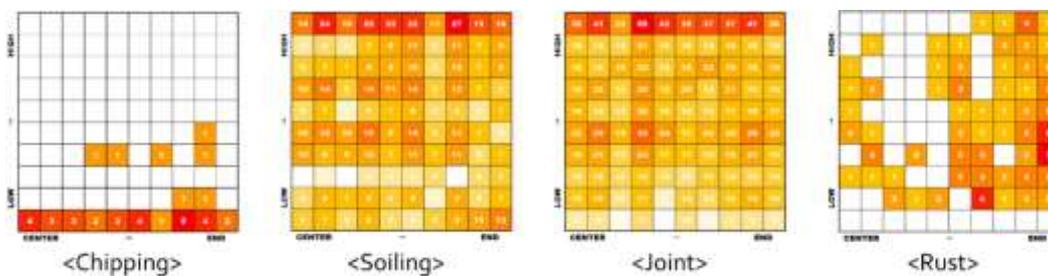
Figure 7. Distribution of Defect Occurrence in Façade

Relation analysis of façade elements and defects examines the correlation between façade elements by extracting properties from a section where defects occurred. An example can be an analysis of the characteristics of defects generated in regard to the horizontal and vertical position of the structure (Figure 7.). As shown in Figure 7., <Chipping> occurred in the lower levels of the building, while <Soiling> and <Joint> occurred in the upper part of the building and <Rust> occurred on the side at a high frequency. It is assumed that the defects occurred according to the possibility of physical contact, contact with rainwater and the position of attachment.

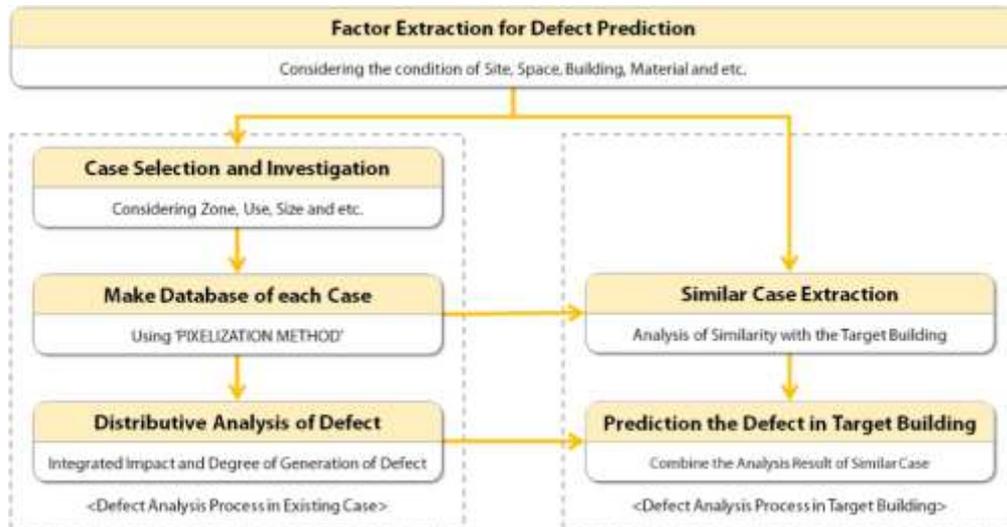
**Figure 8. Prediction Process for the Degree of Defect through Case-based Reasoning**

Anticipation of the degree of defects in a building requires estimation by integration after deducting the degree of defects in similar cases based on building properties, distribution of defects according to building elevation and geographical conditions or use. The degree of defects in an existing building is determined by combining each factor that influences defects in buildings based on information extracted by PM. Afterward, the case is sorted using high rating similarity through case-based reasoning, and the degree of defects is predicted by aggregating the values from high rated cases. The process is shown in Figure 8. Kim (2016)

Based on this process, a foundation can be formed to choose a response strategy such as modification of finishing materials, arrangement of elevation components and proceeding with prior knowledge and acceptance of the degree of defects that will occur in the building.
