A Case Study of Site Conditions and Ground Stability of Town Homes

Tomas U. Ganiron Jr

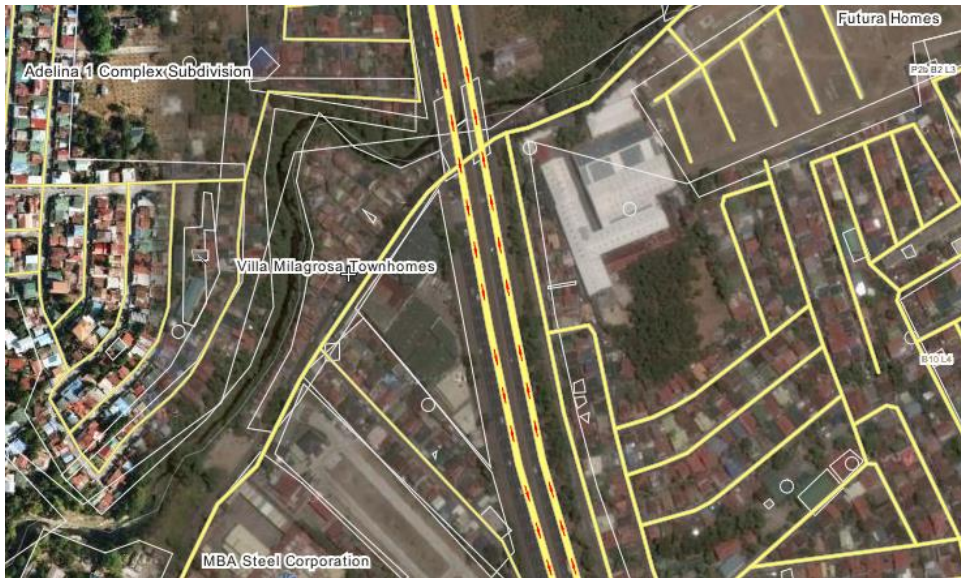
Villa Milagrosa Townhomes (VMT) is situated in village of San Vicente, San Pedro, Laguna. It is centered in geographic coordinate's $14^{\circ}21'13''$ north latitude and $121^{\circ}02'36''$ east longitude. The townhouse is situated on a very well constrained area width ranging from 10-50 meters plate1 sandwiched by the provincial road and crest of the bank of San Pedro River.

San Pedro River is an east draining perennial river roughly 10 kilometers length of plate 1 and 15 meters width, portion near VMT. At the time of the inspection conducted by the geologists from mines and Geo-sciences Bureau, Region 1V, the river is low and has moderate flow.
